Regarding: Reserve Study Final Version

# City View Lofts HOA, Inc.

1755 Central Street  
Denver, CO. 80211

Report Period – 01/01/22 – 12/31/22

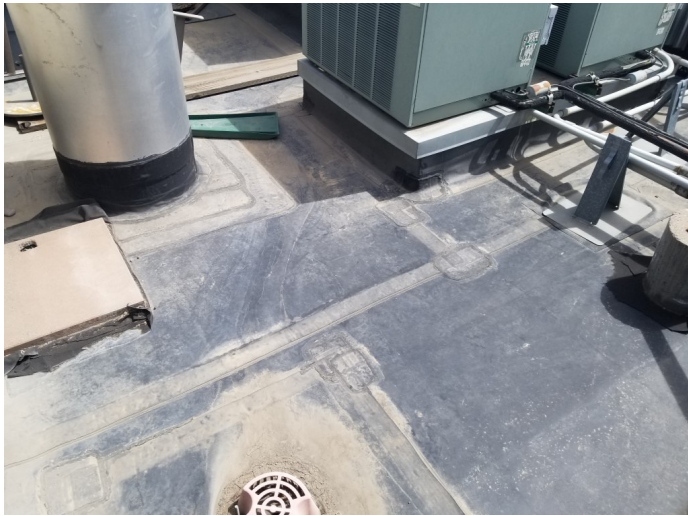
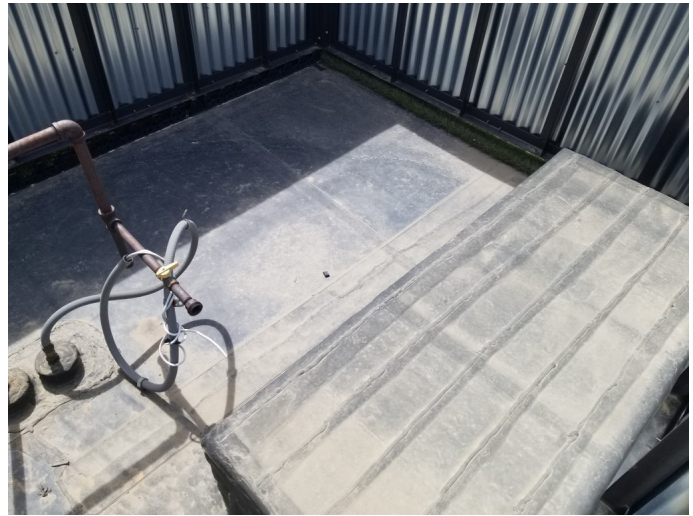
Comp #: 103 EPDM Flat Roof - Replace

- Reported roof needs to be replaced and estimates have been received. It is expected to be replaced in 2021.
- The majority of the roof is covered by personal property (decks, artificial grass areas, etc.) for the upper floor owners.
- No unusual conditions noted on the exposed surfaces at time of site evaluation
- Under normal conditions and with proper maintenance, expect to replace EPDM roofing every 18 - 20 years.
- However, with the majority of the roof covered, we have extended the useful life to 27 years at this time.

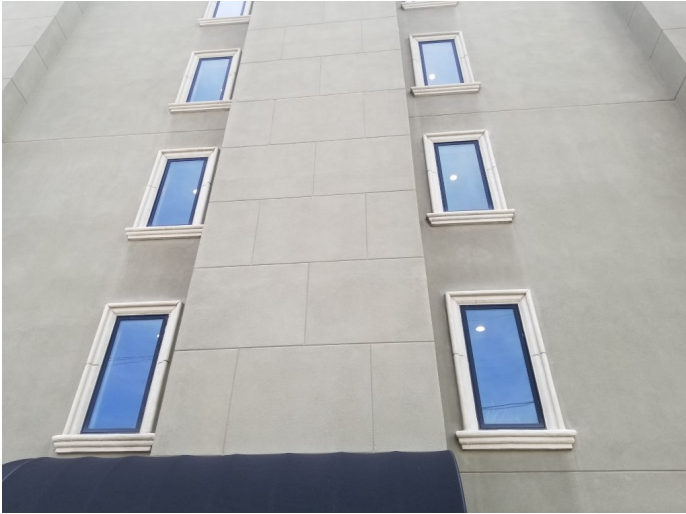
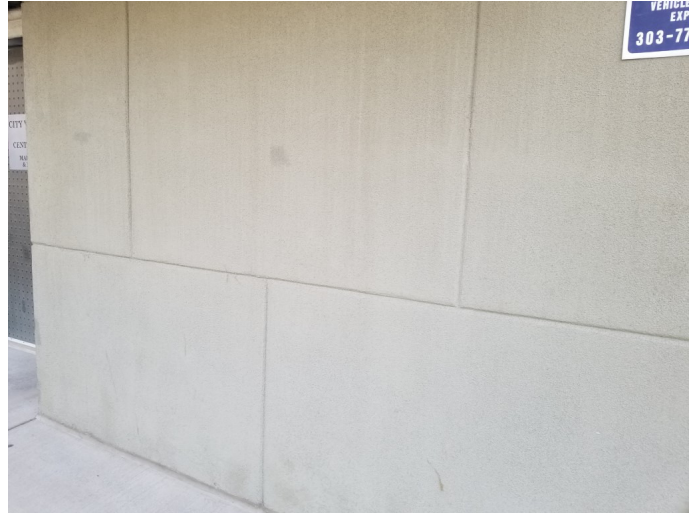
Comp #: 201 Stucco Surfaces - Repaint

- Observed some staining and chalkiness of stucco surfaces.
- Stucco should typically be repainted approximately every 10 to 15 years to protect stucco surface and maintain appearance.
- Painting is done as an alternative to re-applying the stucco for cost effectiveness.
- When stucco surfaces are painted, an elastomeric or acrylic paint should be used according to industry professionals.

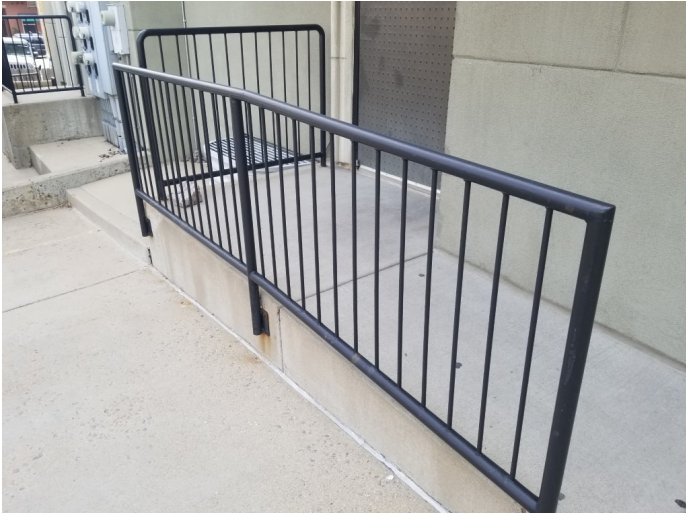
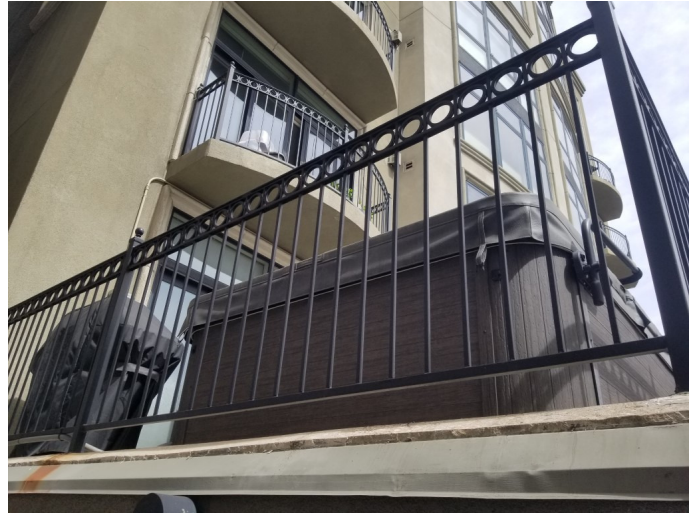
Comp #: 207 Railing - Repaint

- In this climate, we recommend repainting this component every 4 - 6 years to maintain appearance and protect metal surfaces.
- Remaining life based on current condition.
- Coordinate with other painted surfaces when possible for best cost estimate

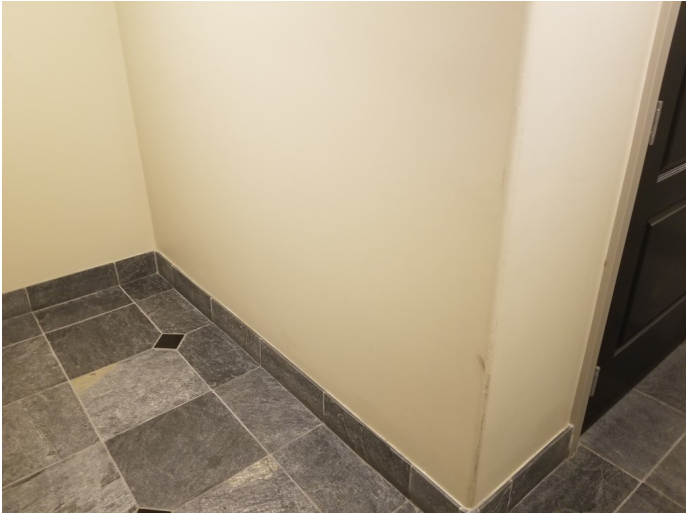
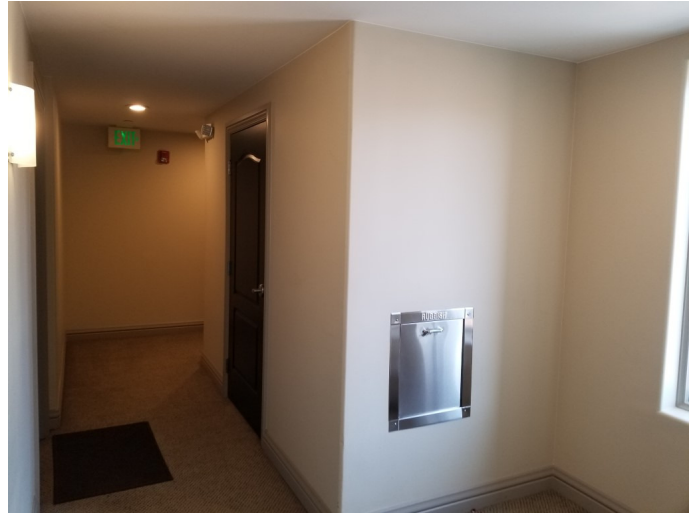
Comp #: 216 Interior Surfaces - Repaint

- We recommend reserving to repaint the interior spaces every 8 - 12 years to maintain appearance.
- Outside of this painting cycle, damage to the surfaces and touch-up work should be performed annually with operating funds.
- NOTE - We have deferred this project until 2023 to spread out the major expenses and ease budgeting concerns.

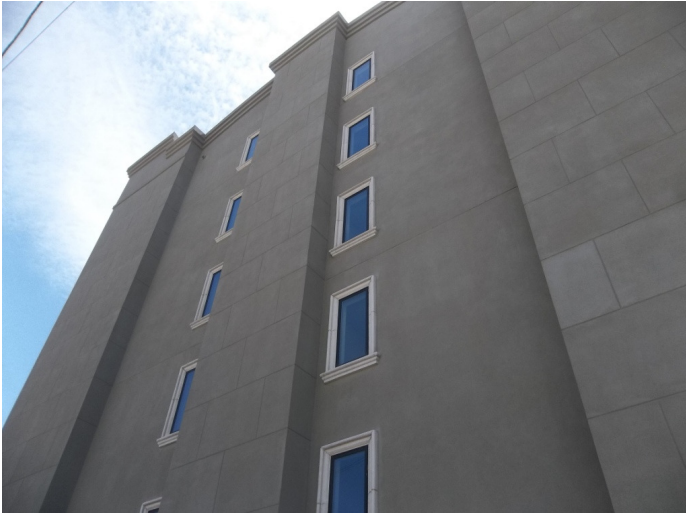
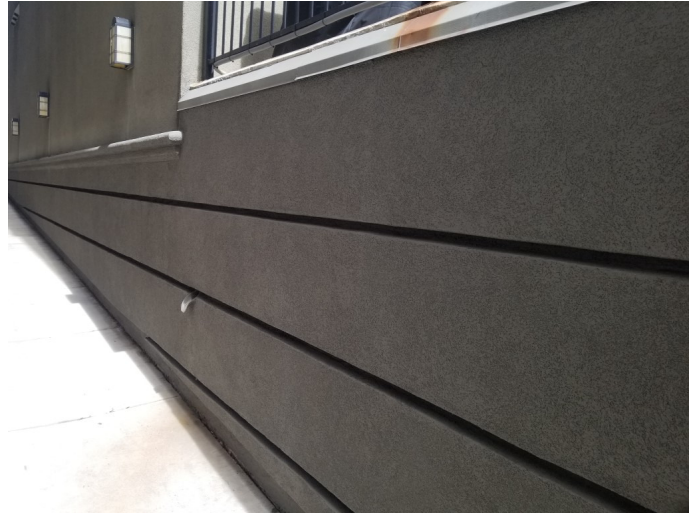
Comp #: 307 Stucco - Repair

- While stucco surfaces have a long life expectancy (typically a 10 year labor warranty), it is recommended by industry professionals to inspect and repair any cracks/voids frequently to prevent water intrusion.
- It is also recommended that a new coating is applied every 10 - 15 years to maintain an appropriate appearance (see component #201).
- Over a period of time, minor cracks and voids will develop that will require repairing.
- Coordinate these repairs with a painting cycle every 12 years.

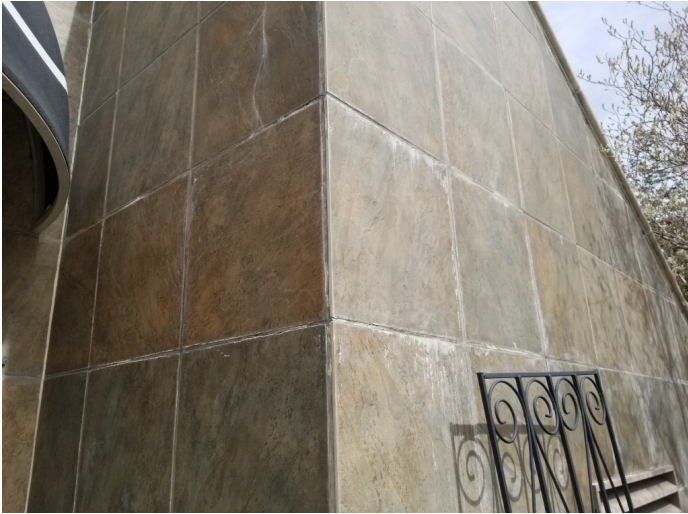
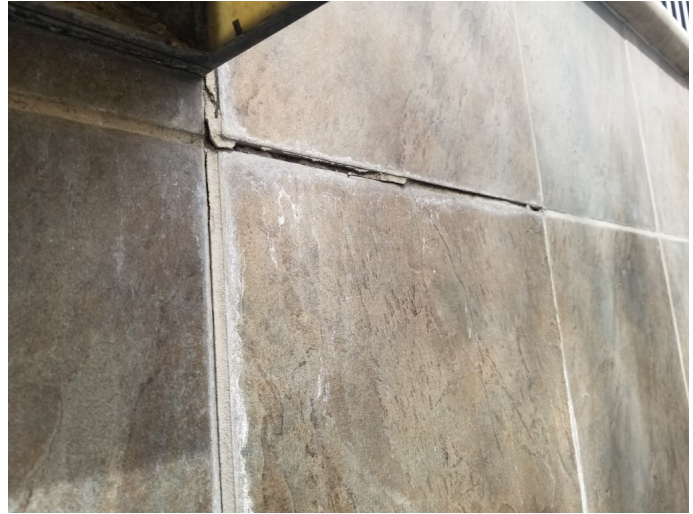
Comp #: 309 Tile - Major Repairs

- Observed a few loose tiles and what appears to be possible water intrusion from behind the tiles.
- Unless the association decides to replace the tiles due to a dated appearance at some point in the future, we recommend establishing Reserve funds for periodic major repairs.
- The remaining life is based on observed conditions

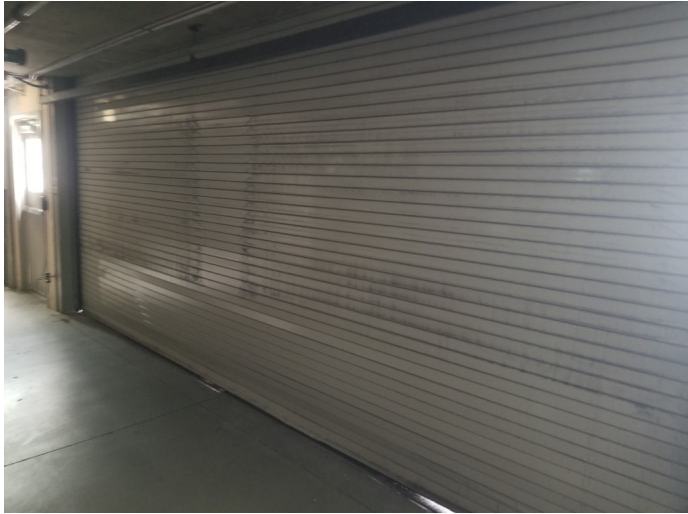
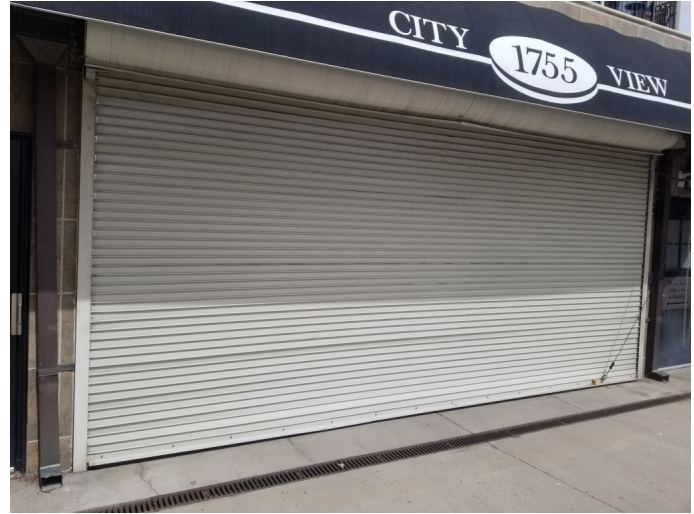
Comp #: 502 Garage Door - Replace

- In our experience, we have seen the need to replace these doors every 15 - 18 years on average.
- There has been no reports of major maintenance or replacement, so we are assuming door is still original.
- While door may be functional, the association should be financially ready for replacement at any time in the near future.
- Per client request, remaining life extended to 2025

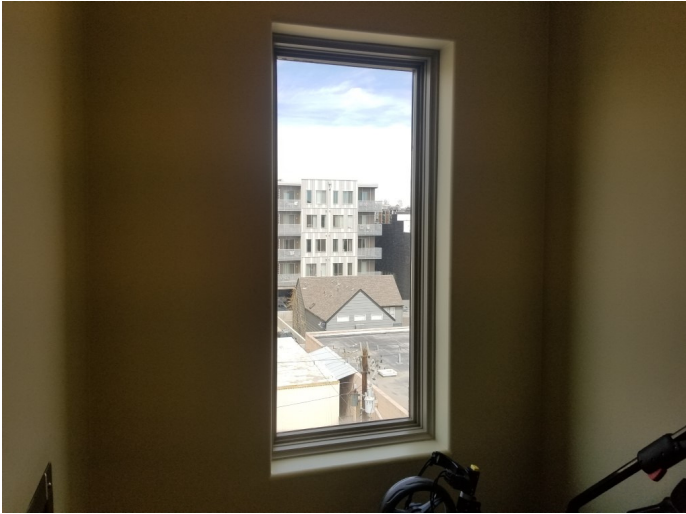
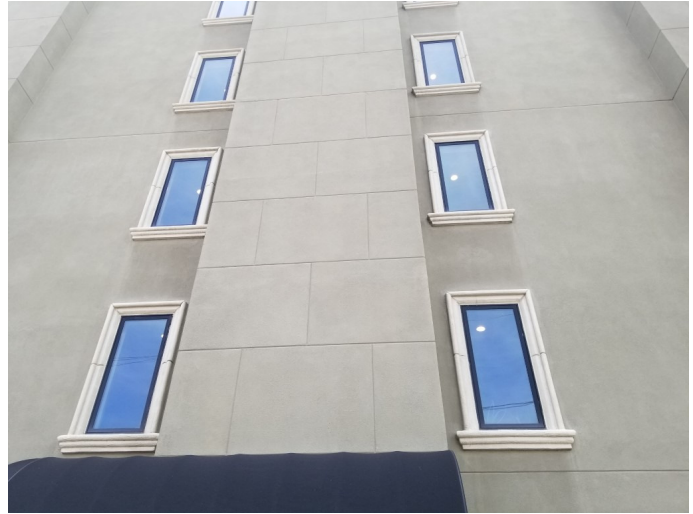
Comp #: 506 Windows - Replace

- In our experience, we have seen the need to replace common area windows and doors every 25 - 30 years on average.
- Per client request, remaining life extended 15 years

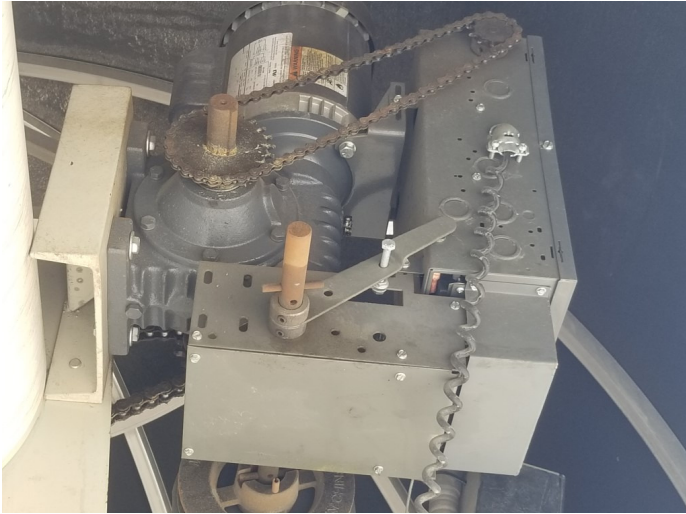
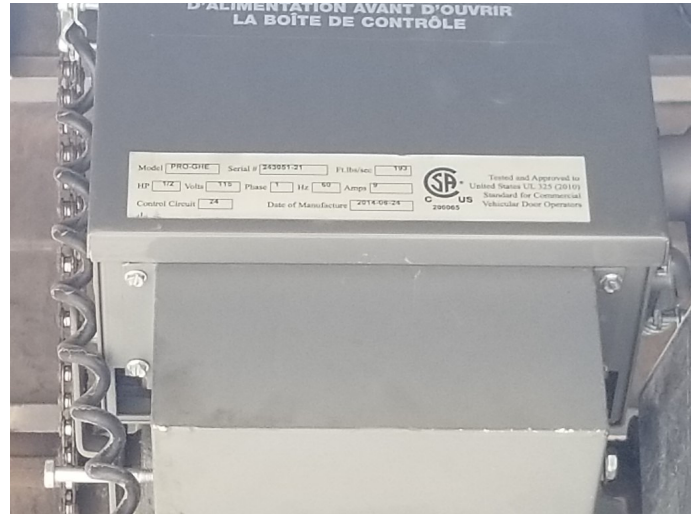
Comp #: 507 Garage Door Operator - Replace

- Appears unit was replaced in 2014
- While some parts of the opener can be replaced in lieu of replacing the entire assembly, we recommend the association plan to replace the entire assembly every 8 - 10 years
- Perform semi-annual maintenance as an operating expense to maximize the useful life of the operators.
- Reported Board will be implementing a maintenance program. Extend life by 3 years

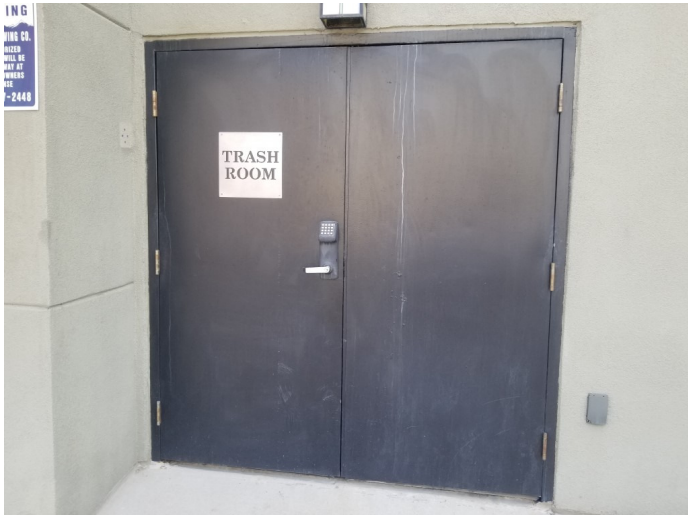
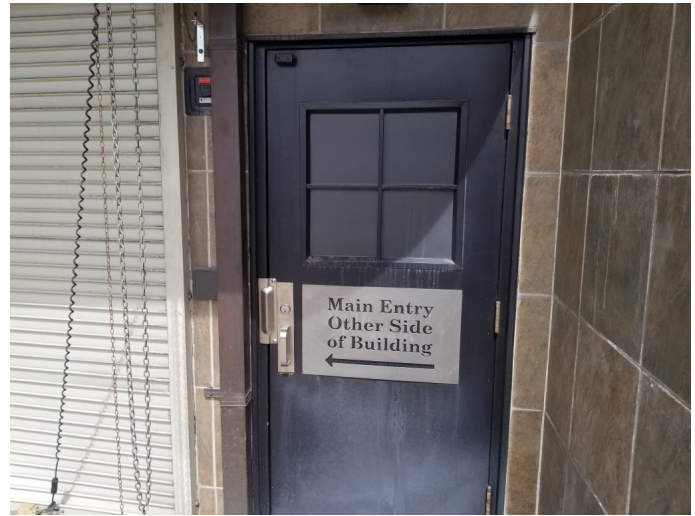
Comp #: 508 Common Doors - Replace

- Depending on the level of use and care, expect to replace these doors every 25 - 35 years.
- No extensive signs of deterioration or condition changes since the last on site visit. Therefore, we have extended the replacement cycle to 35 years at this time.
- Adjust remaining life in future Reserve Study updates depending on the deterioration levels for this property

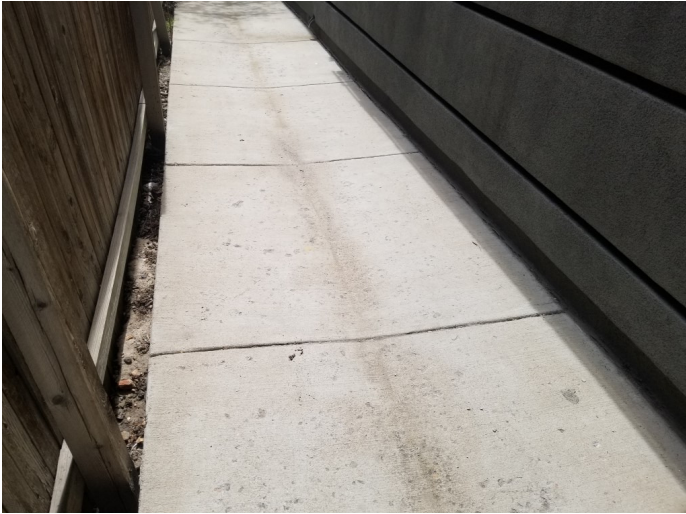
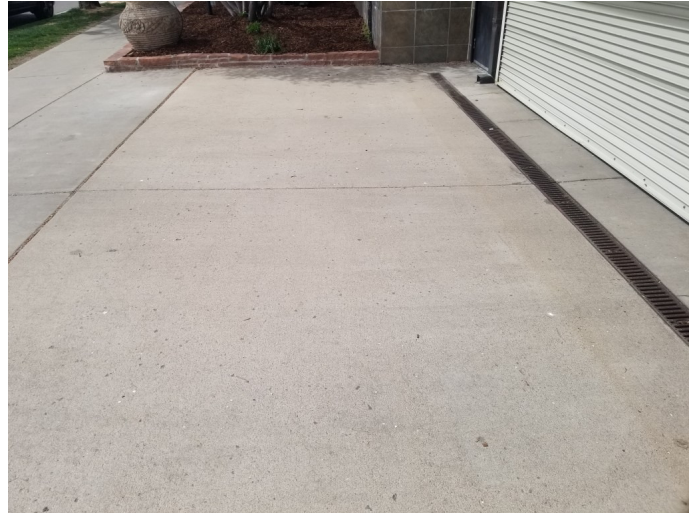
Comp #: 601 Concrete - Repair/Replace

- We recommend establishing an allowance of 10% of the total area measured (475 GSF) to be repaired every 7 years.
- As the property ages, it is possible the percentage, or frequency, of repairs will need to be adjusted in future Reserve Study updates.
- Per client, no signs of deterioration. As a result, remaining life was extended to 6 years

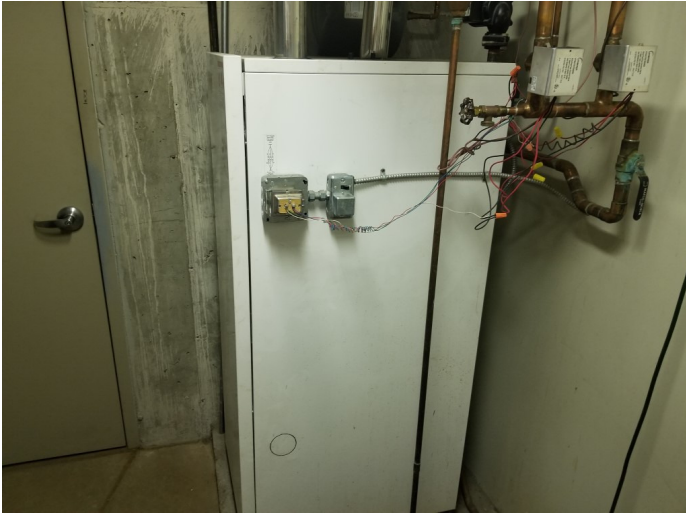
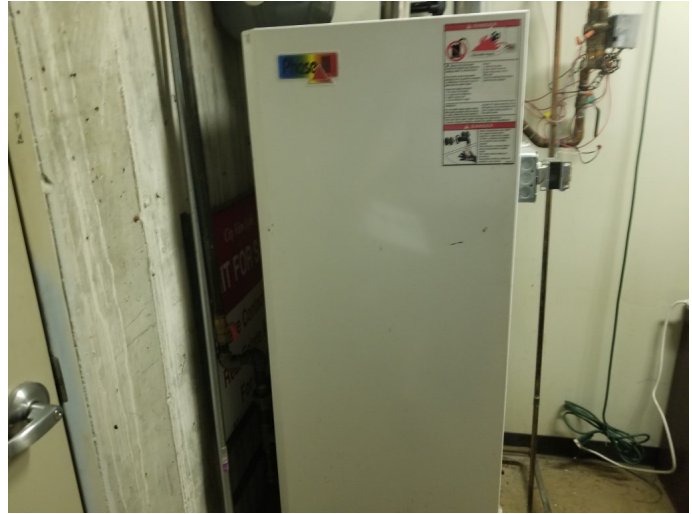
Comp #: 703 Water Heater - Replace

- Joints and connections were in good shape and free from significant rusting and corrosion. Despite these conditions, water heater has exceeded the average life expectancy of 15 - 18 years.
- As a result, even though the heater is functional, we recommend the association plan for replacement at any time in the near future.
- Depending on the level of use and the quality of the water running through the system, expect a useful life of 12 - 15 years from water heaters with proper maintenance and care.
- Remaining life was extended to 5 years per client request.

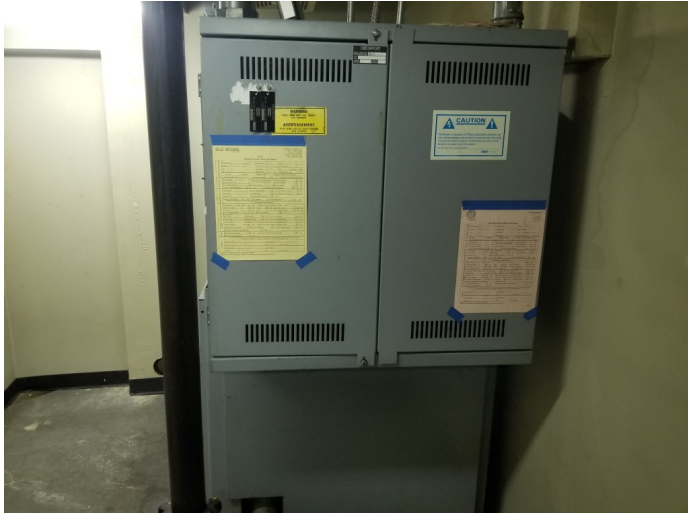
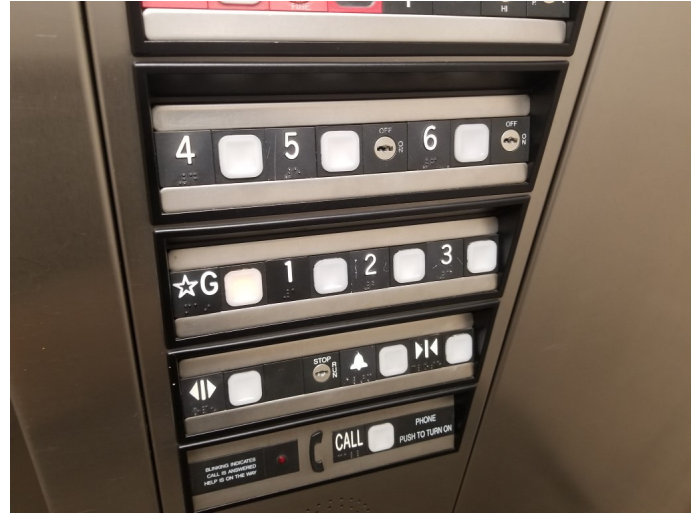
Comp #: 707 Elevator - Rebuild/Upgrade

- In order to maintain a safe environment, it is generally recommended by elevator contractors that the "brains", door assemblies and other automation features in the elevator are updated every 20 - 25 years.
- Have the equipment professionally inspected and tested every year to ensure the equipment is working properly.
- NOTE - We tried contacting Elevators Unlimited, but the call would not go through and the website does not exist.
- Per client request, due to maintenance program in place, extend remaining life to 6years

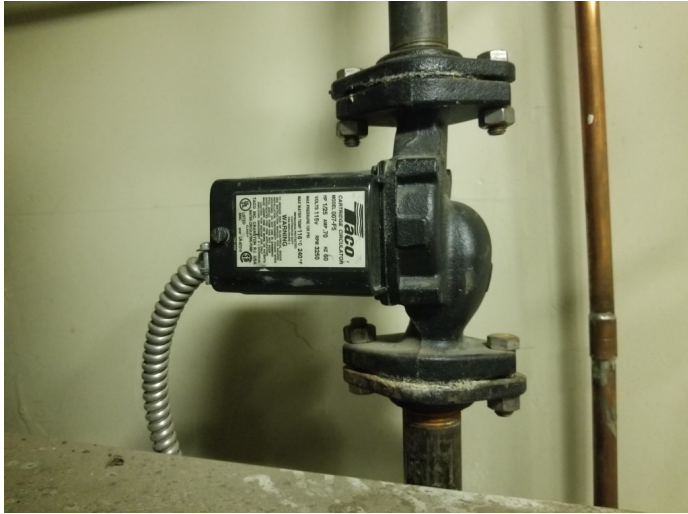
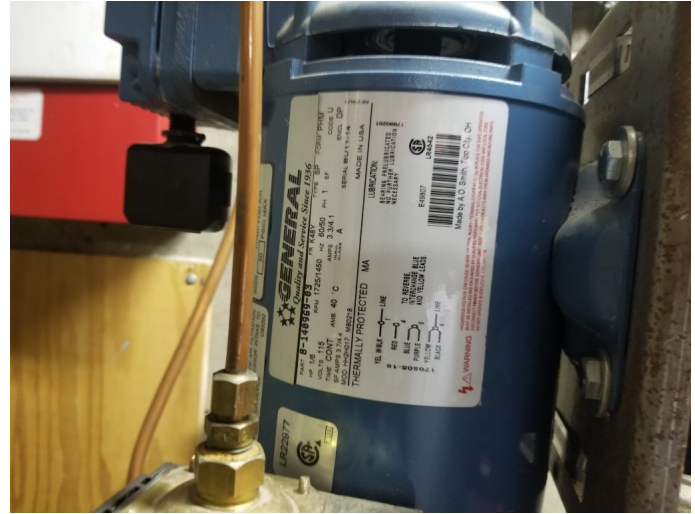
Comp #: 715 Pumps - Partial Replace/Major Repairs

- Fire pump was repaired in 2019. Details of the repairs were not provided on the proposal received.
- Due to varying ages, sizes, and levels of use, we recommend establishing an allowance for periodic major repairs or partial replacement.
- This line item is not intended to be represent complete replacement of all pumps/motors at the same time.
- Per client request, extend remaining life to 5 years

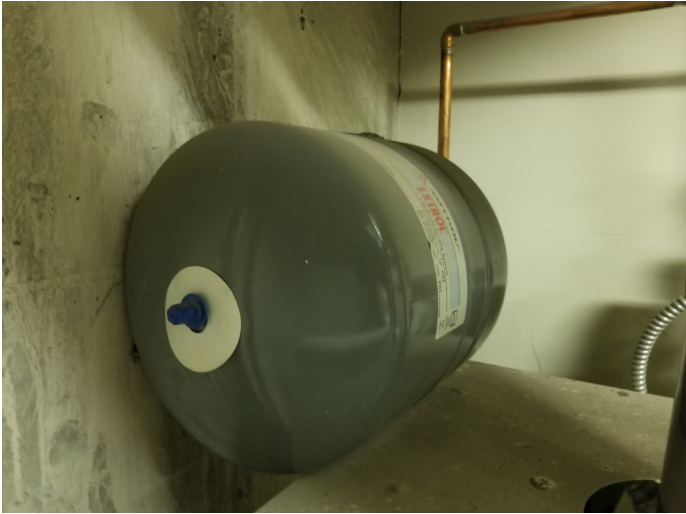
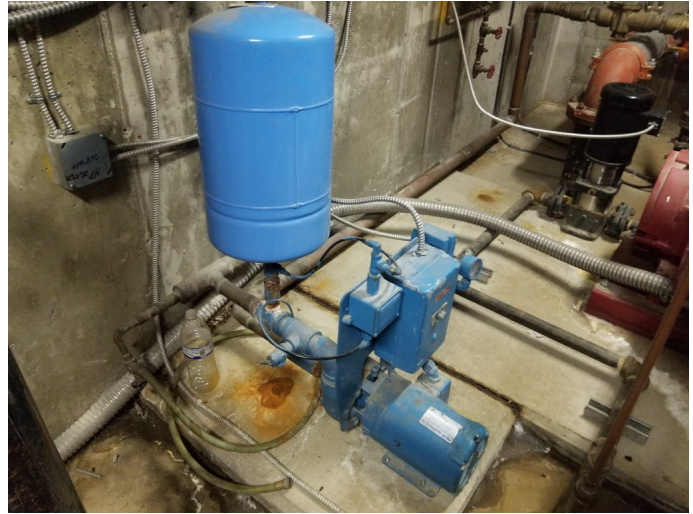
Comp #: 721 Expansion Tanks - Replace

- Under normal conditions and without sudden pressurization, these tanks typically have an indefinite life expectancy.
- Also, the replacement cost of these sized tanks is often too small for separate Reserve funding consideration
- Therefore, at this time, we recommend replacing on an as needed basis with general operating funds.

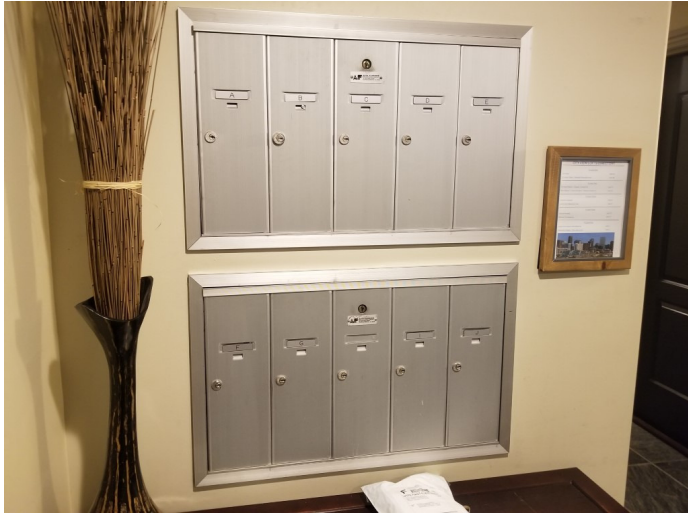
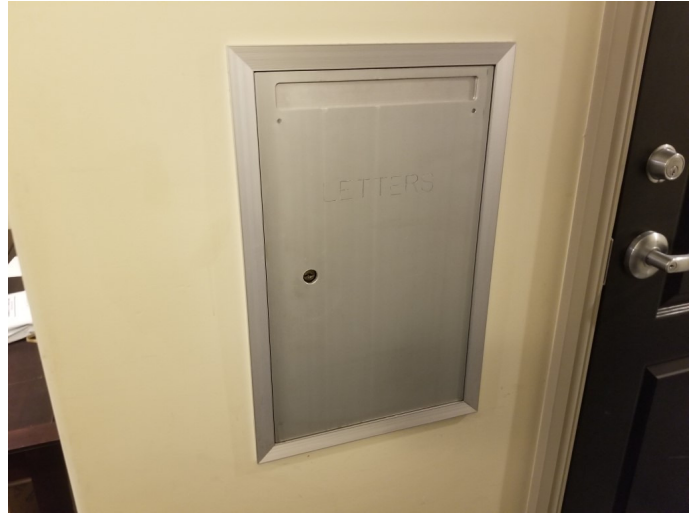
Comp #: 803 Mailboxes - Replace

- Mailboxes appeared to be in good condition, considering age of building, at time of observation with no reports of problems.
- Due to the location of the mailboxes being inside and protected from the elements, we do not expect these mailboxes to require replacement more often than every 20 years.
- Due to extended life expectancy and low replacement cost, we recommend replacing as needed with operating funds.

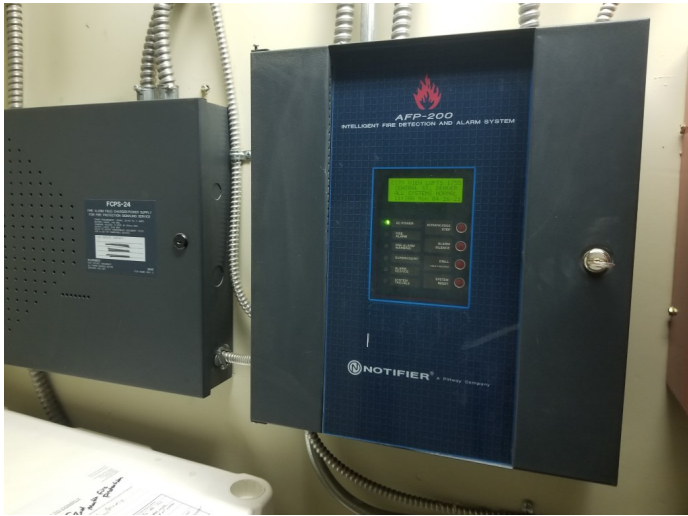
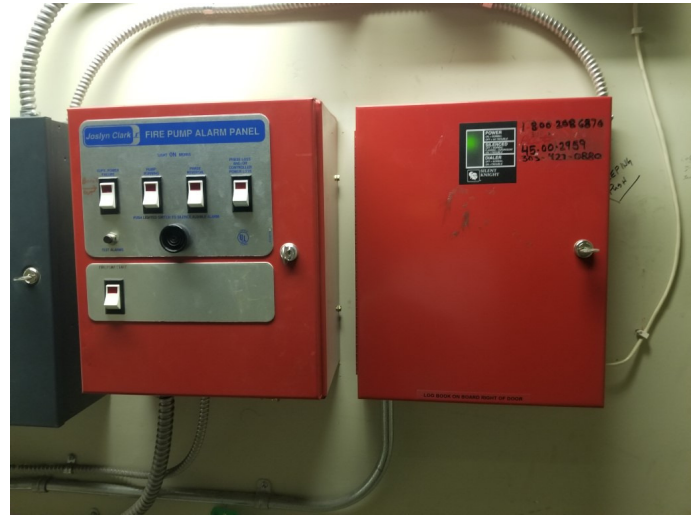
Comp #: 901 Fire Protection System - Replace

- Once the system is installed, it is unlikely that any rewiring will be required; replacement costs reflect replacement of the panels only.
- Expect to replace these panels every 20 - 25 years depending on levels of maintenance and under normal conditions.
- System should be tested annually by a professional to ensure functioning conditions during an emergency.

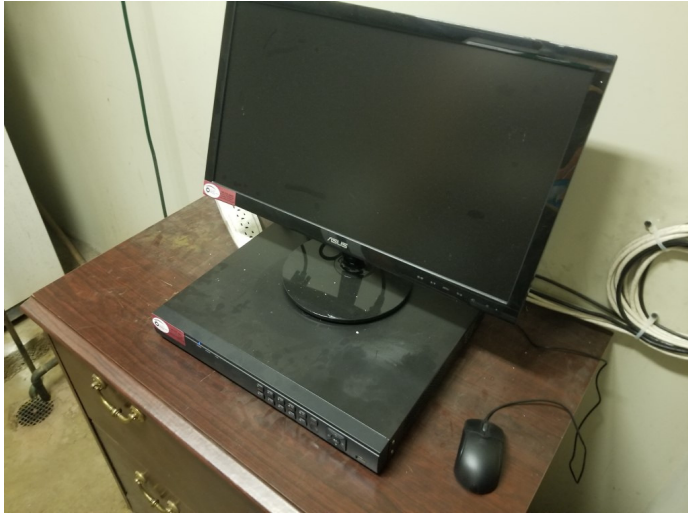
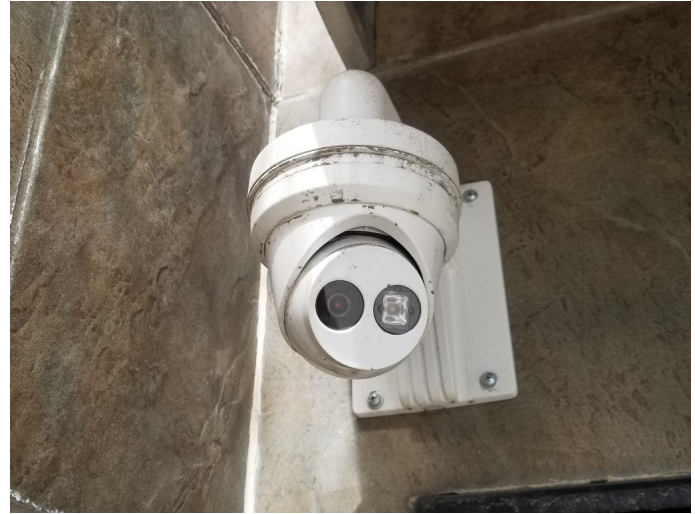
Comp #: 903 Security System - Replace

- Per service contractor, system was installed in 2019, and there have not been any reported problems since system was installed.
- Under normal conditions, expect to replace the system and upgrade every 5 - 6 years due to advances in technology.
- Remaining life is based on age of system
- Per client request, extend remaining life to 5 years

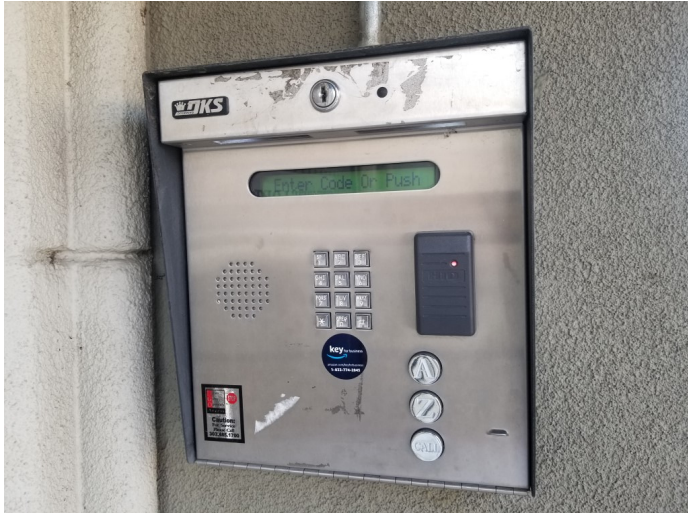
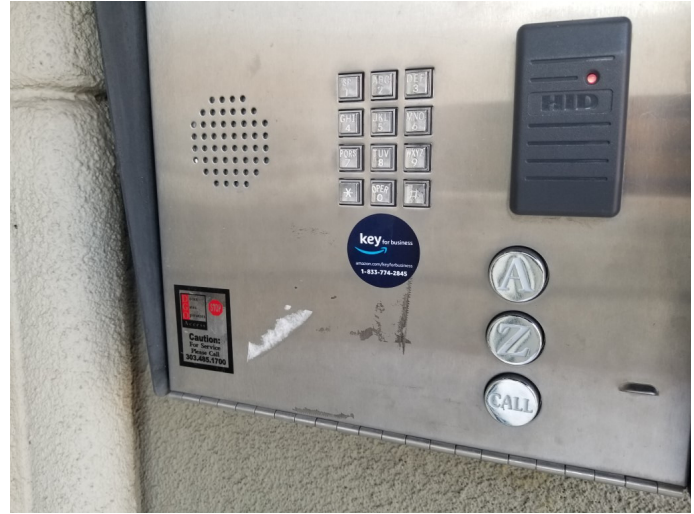
Comp #: 905 Intercom - Replace

- New system most likely installed within the past 5 years.
- This type of system has a typical life expectancy of 12 - 15 years in this climate.
- Remaining life is based on approximate age and observed conditions.

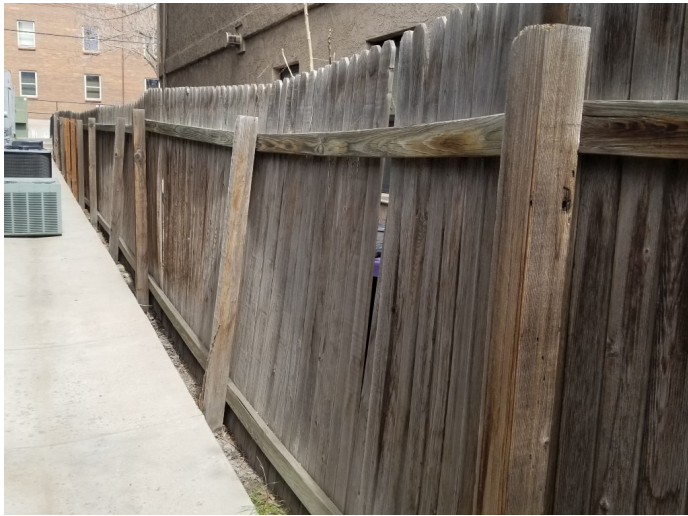
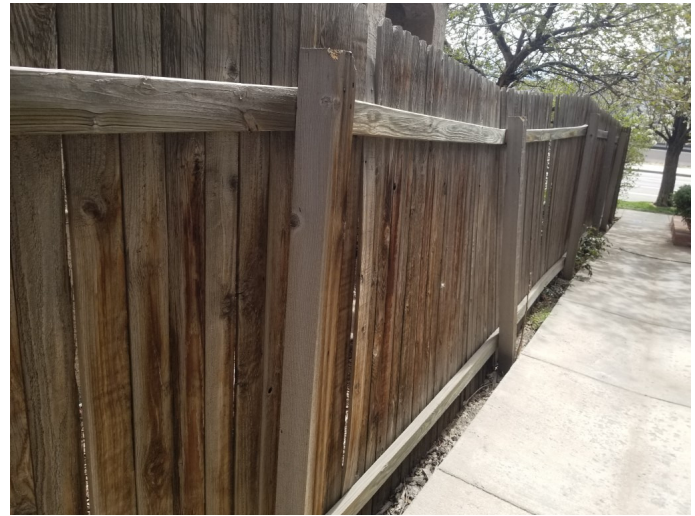
Comp #: 1001 Privacy Fencing - Replace

- Fence is leaning in a few areas, but the pickets and overall condition is fair. We suggest replacing the posts as an operating expense to extend the life of the fence.
- The average replacement cycle ranges between 15 - 20 years and is based on the observed quality of fence installed and the current condition.
- It was reported the fence is on the neighboring property and is not the responsibility of City View. Therefore, Reserve funding has been removed from the report.
- This inventory page is included for informational purposes only.

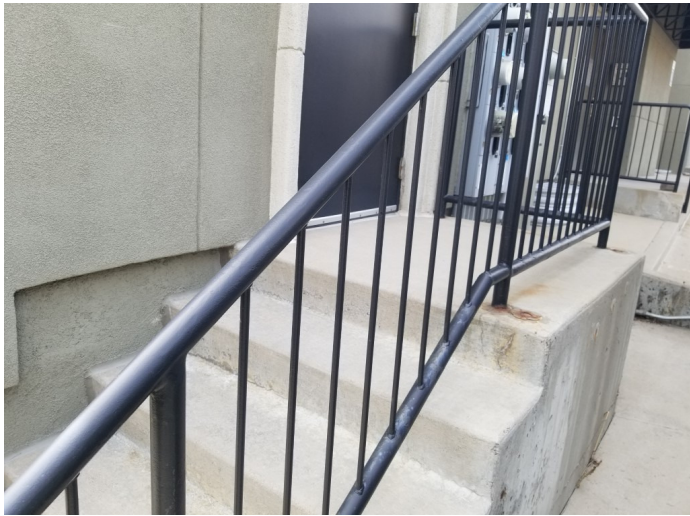
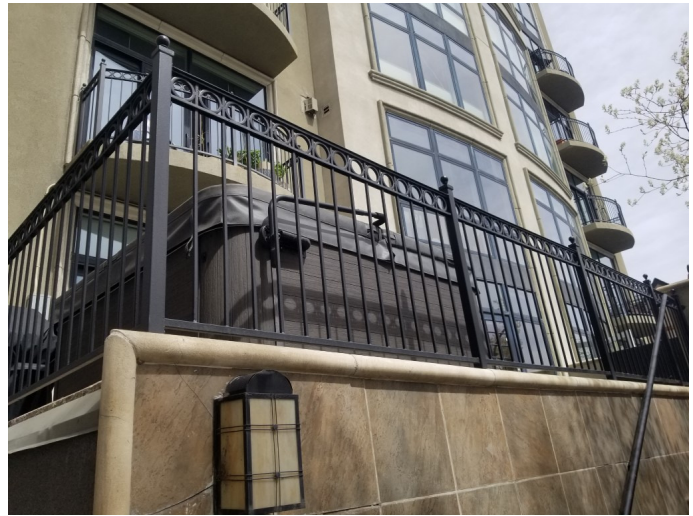
Comp #: 1002 Metal Railing - Replace

- The average replacement cycle for this type of railing typically ranges between 25 - 35 years, depending on maintenance levels and exposure to elements.
- Since we were unable to access and inspect the condition of the balcony railing, this line item is included as a conservative safety measure in case balcony railings deteriorate over the years from snow melt chemicals.

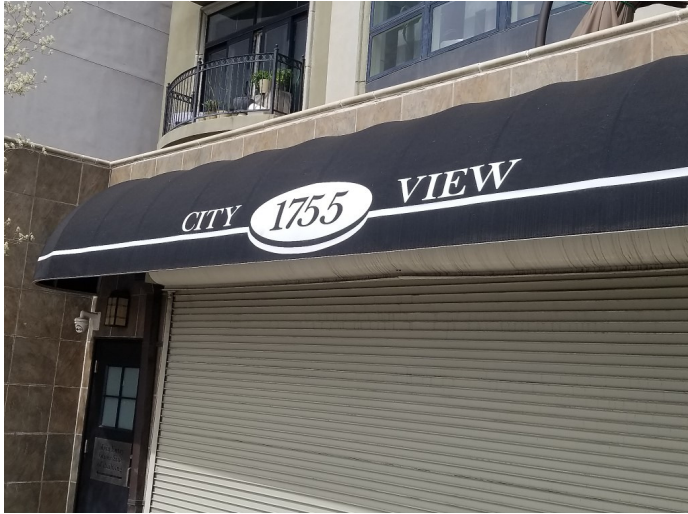
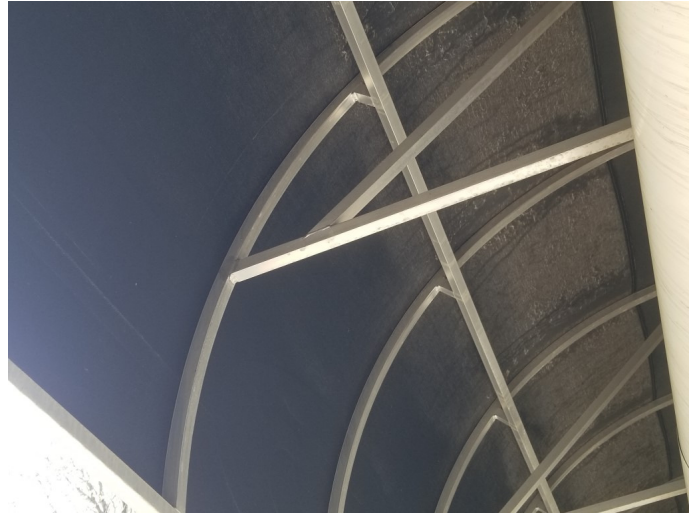
Comp #: 1314 Canvas Awning - Replace

- No reported replacement, but based on the appearance of the fabric, awning has been replaced at some point within the past couple years.
- Metal frames were free from any deterioration or damage at time of observation.
- This line item is for replacement of the awning fabric every 7 - 8 years.

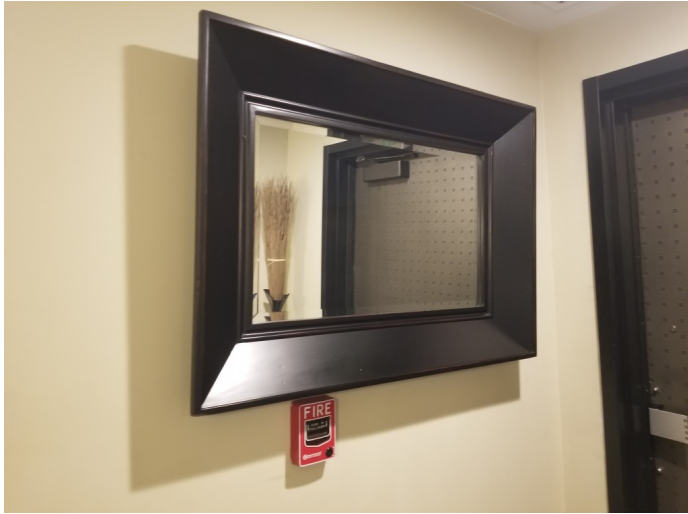
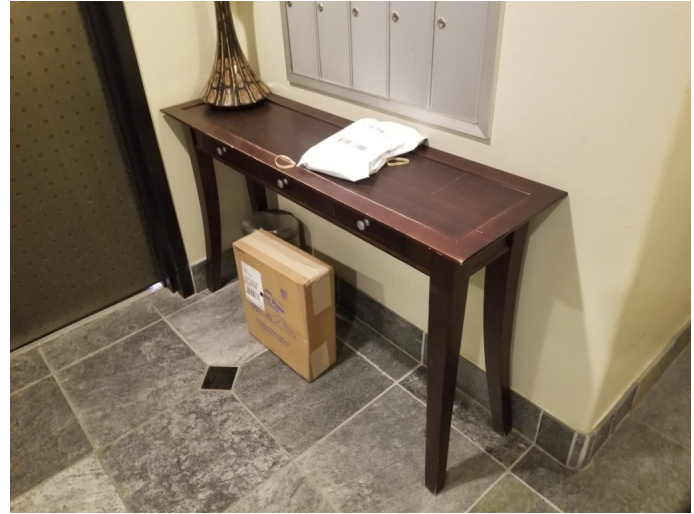
Comp #: 1405 Furnishings - Replace

- Due to low quantity of furnishings we do not recommend reserving to replace at this time.
- Replace furnishings on an as needed basis using operating funds.

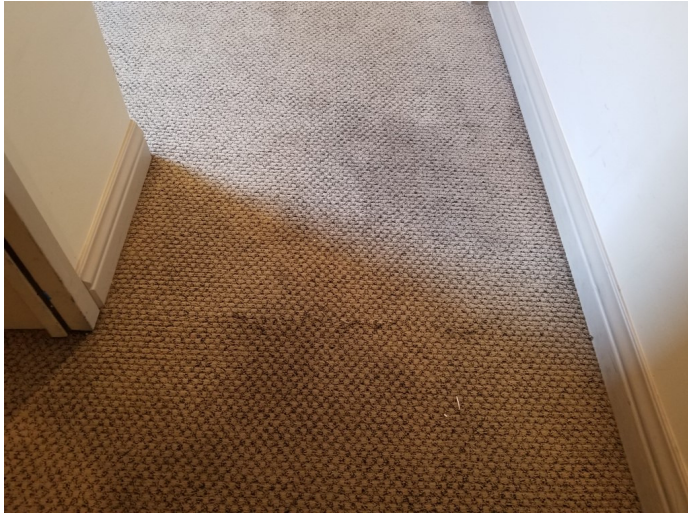
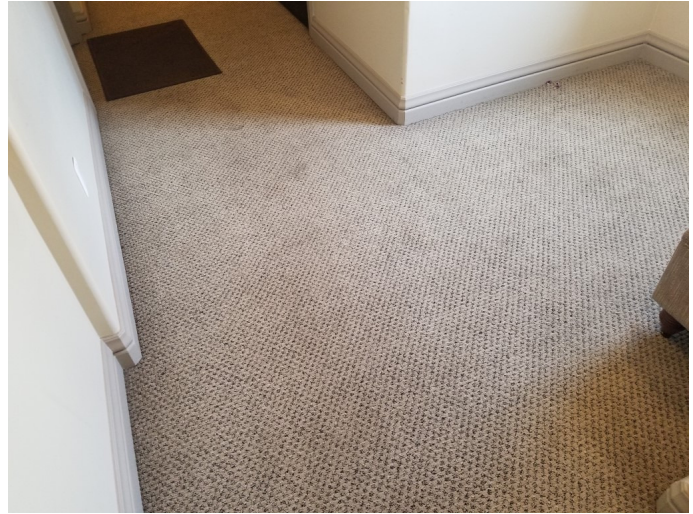
Comp #: 1501 Carpeting - Replace

- Seams are starting to appear in some areas, as well as numerous stains were observed as well.
- This type of carpet and application has a typical useful life of 10 to 12 years.
- The remaining life is based on the overall appearance of the carpet and the assumed age
- NOTE - We have deferred this project until 2024 to spread out the major expenses and ease budgeting concerns.

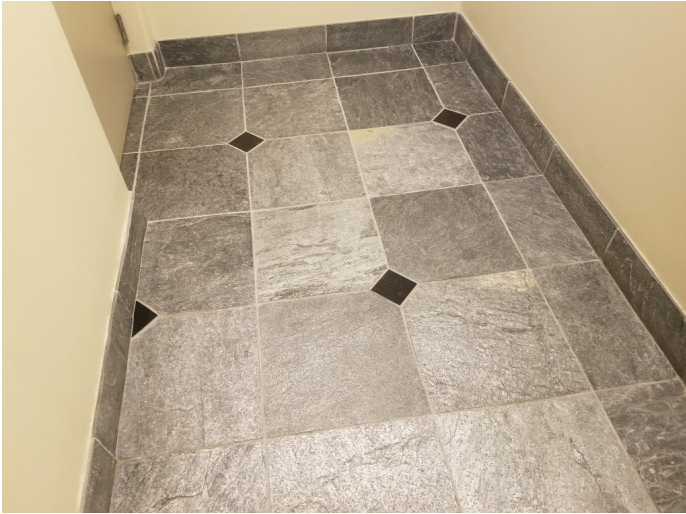
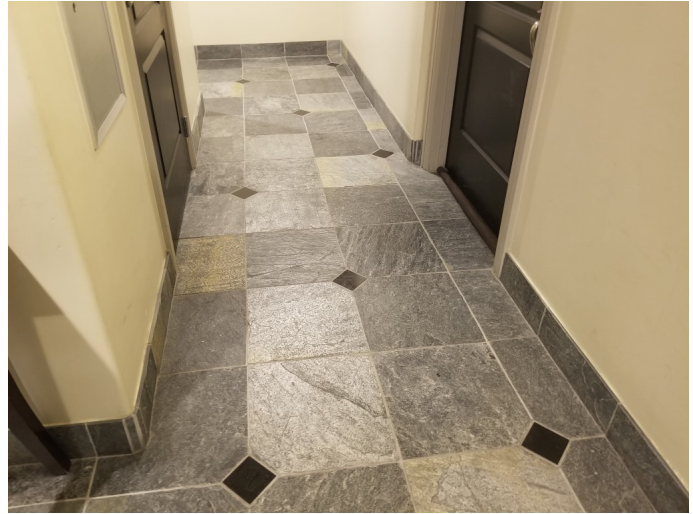
Comp #: 1504 Tile - Replace

- Tiles are functional, but somewhat outdated in appearance.
- The tile will not likely be replaced because the material fails, we have included funding so the association is prepared to replace the tile based on changes in decorative trends.
- In order to maintain a modern and appropriate appearance, reserve to replace lobby tile every 20 - 25 years.
- Coordinate with carpet replacement so tile is consistent with the current decorative trends
- NOTE - We have deferred this project until 2024 to spread out the major expenses and ease budgeting concerns.

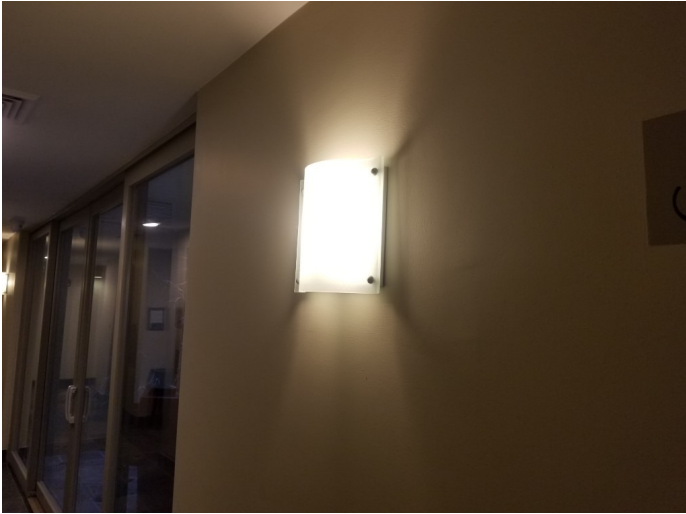
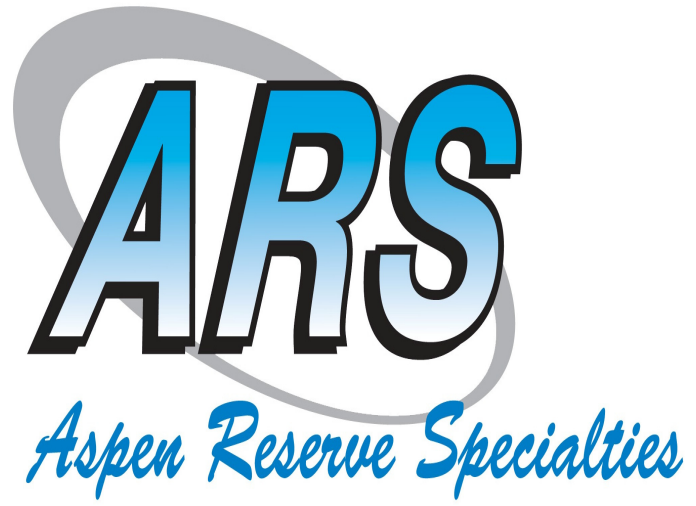
Comp #: 1601 Interior Hallway - Replace

- Typically, associations prefer to upgrade and modernize lighting every 15 - 20 years, depending on changes in trends.
- Suggest replacing all fixtures at same time to get best cost estimate and match décor throughout all buildings.
- Replace non-decorative lights (florescent lights, recessed can lights, etc.) on an as needed basis with operating funds
- NOTE - We have deferred this project until 2024 to spread out the major expenses and ease budgeting concerns.

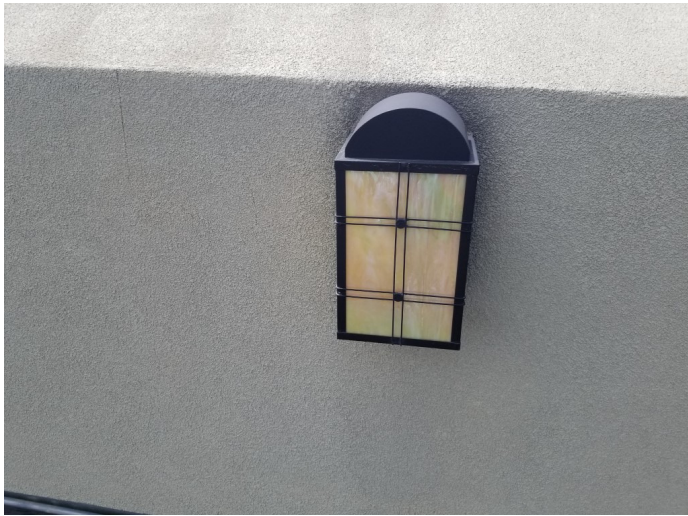
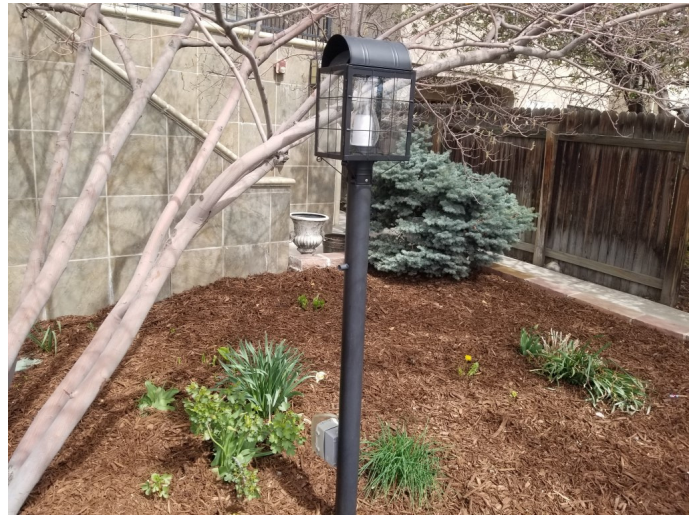
Comp #: 1602 Exterior Wall Mount - Replace

- While replacement can occur on an as needed basis, it is our opinion and recommendation to replace all lights at the same time every 15 - 20 years to maintain a consistent appearance throughout the property.
- By replacing multiple fixtures, the association will be able to obtain a quantity discount for replacement and installation of the fixtures.
