Regarding: Reserve Study Final Version

# City View Lofts HOA, Inc.

1755 Central Street  
Denver, CO. 80211

Report Period – 01/01/22 – 12/31/22

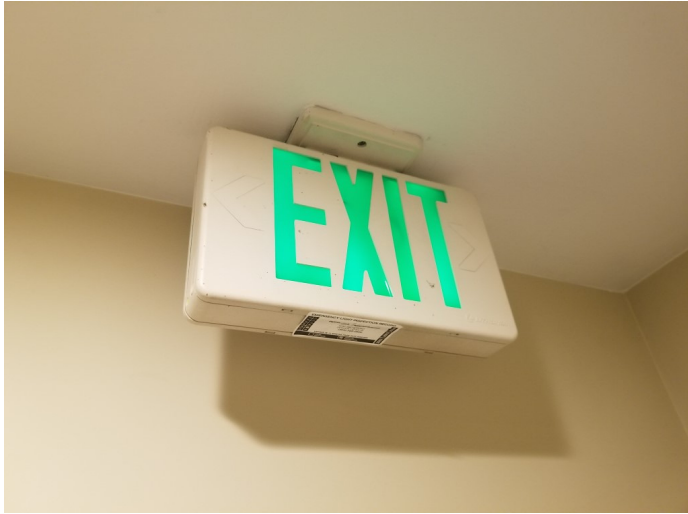
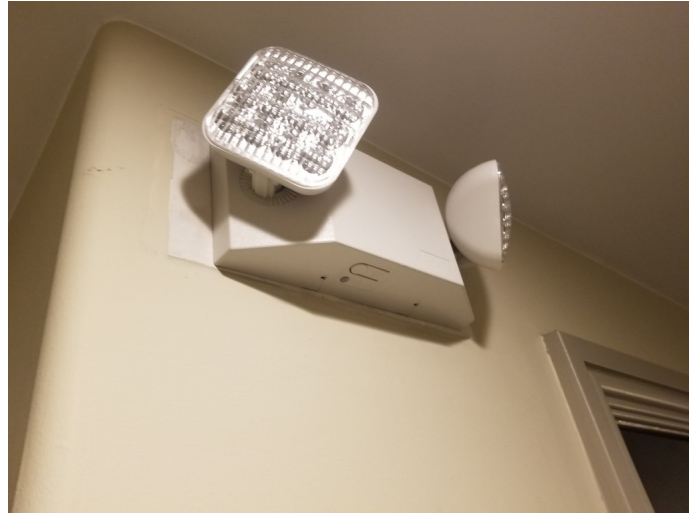
Comp #: 1611 Miscellaneous Lighting - Replace

- These should be tested at least twice a year to ensure proper function during an emergency situation.
- Due to low individual replacement cost, we suggest replacing on an as needed basis with general operating funds.

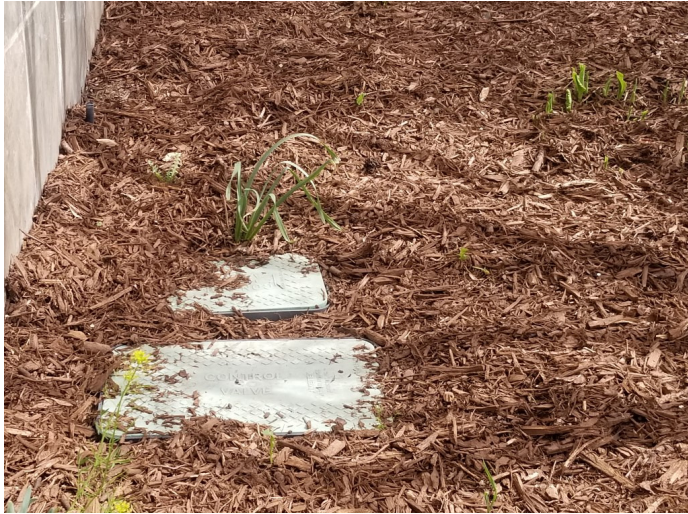
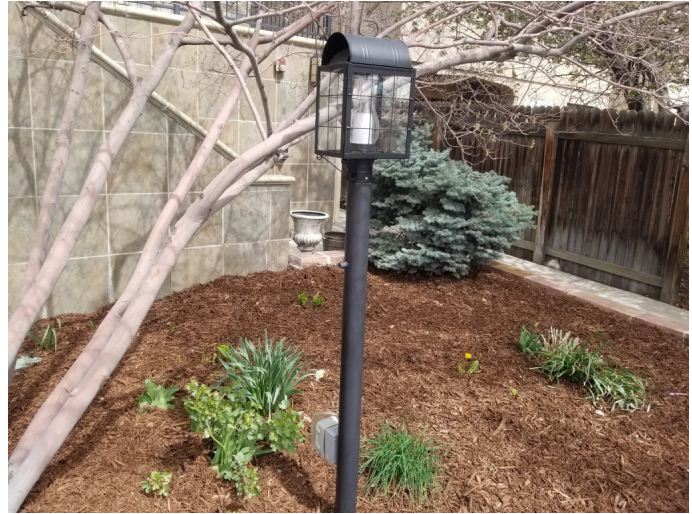
Comp #: 1701 Irrigation System - Replace

- Due to the small area of landscaping and irrigation, we recommend continuing to handle everything on an as needed basis using operating funds.
- No reserve funding necessary for the small landscaped area and small irrigation system.

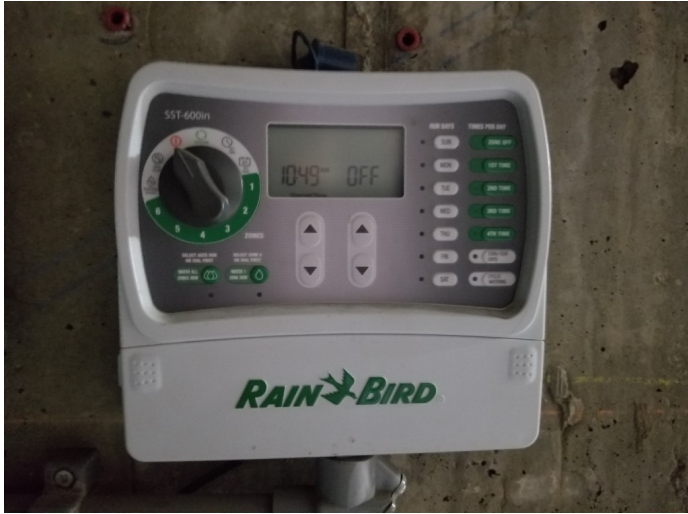
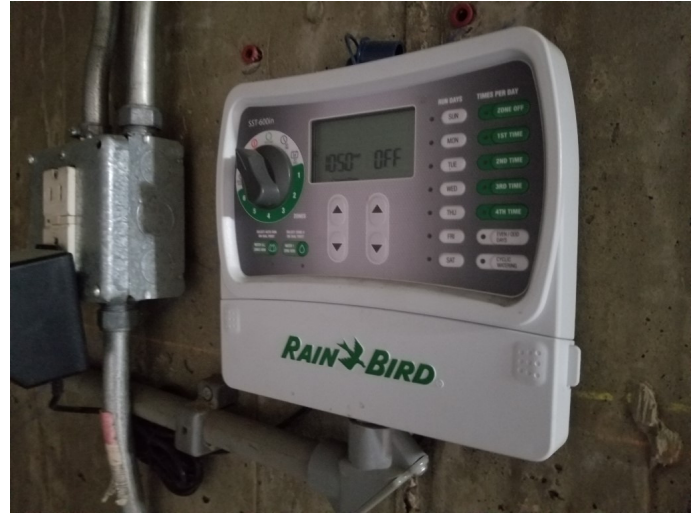
Comp #: 1703 Irrigation Controllers - Replace

- Due to the low cost of replacement, we do not recommend reserving to replace at this time.
- Replace as needed using operating funds.

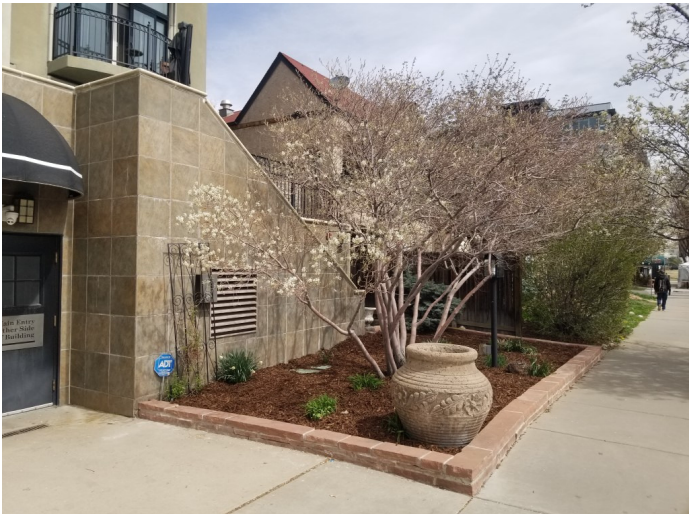
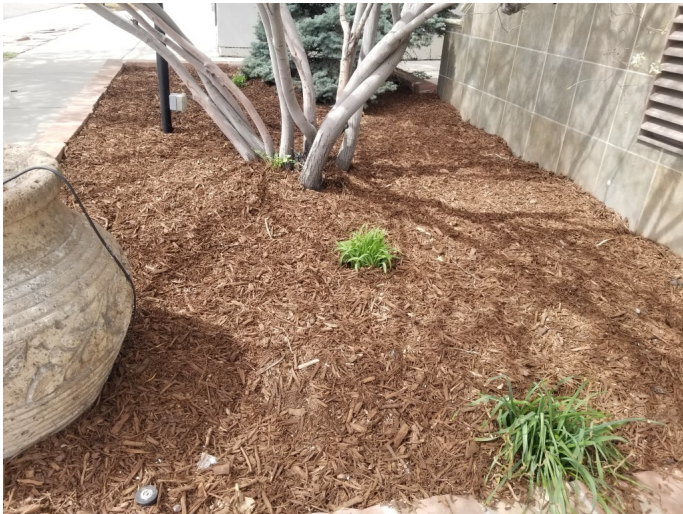
Comp #: 1801 Groundcover - Replenish

- Typically, associations will establish a line item in the operating budget to handle annual replacement of shrubs, plants, mulch, etc.
- Therefore, separate Reserve funding is not necessary as long as funding has been established in a separate budget.
- If the association prefers to include a funding allowance for groundcover replenishment, then we would need to know how much and how often the current board of directors would prefer to set aside since this would be considered a discretionary expense.
