Regarding: Reserve Study Final Version

# City View Lofts HOA, Inc.

1755 Central Street  
Denver, CO. 80211

Report Period – 01/01/22 – 12/31/22

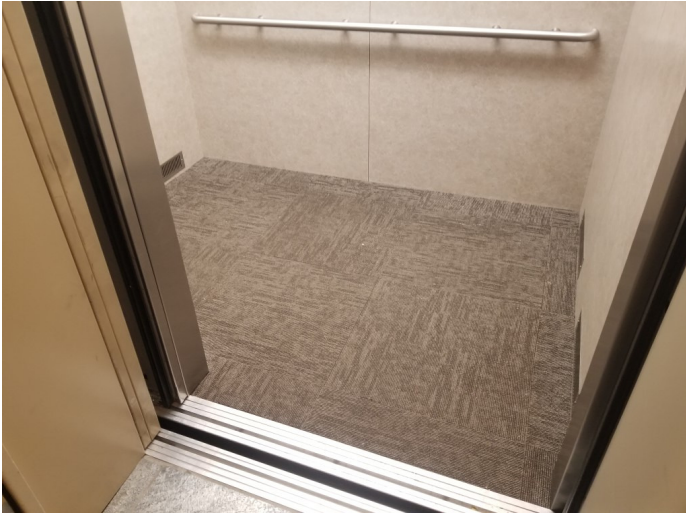
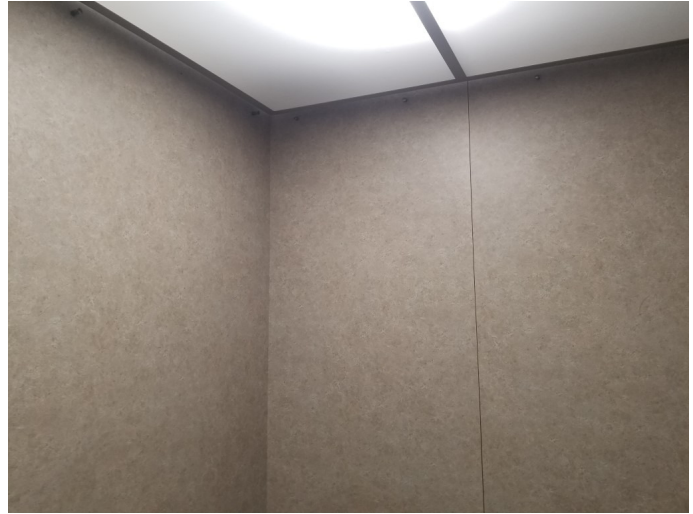
Comp #: 709 Elevator Cab - Remodel

- Timing of remodels and décor choices depend on the association ownership and desires to improve appearance.
- Per Colorado conveyance regulations, it is required that a licensed elevator contractor oversee all cab renovations unless you are replacing like-for-like (e.g. replacing old tile with new tile). New interiors also have to be permitted with the state so that they meet code standards such as flame spread ratings, retain proper ventilation, etc.
- On average, most associations perform a remodel on elevator cabs every 12 - 18 years, depending on quality of finishes and level of use/care.
- Per client request, no remodel planned, extend remaining life to 5 years
